## THATCHERS ASSOCIATION OF SOUTH AFRICA DEKKERSVERENIGING VAN SUID-AFRIKA

NEWSLETTER 2/2018  
7 March 2018

### When is a roof repairable or not?

### **Here is a structural problem that was recoverable**

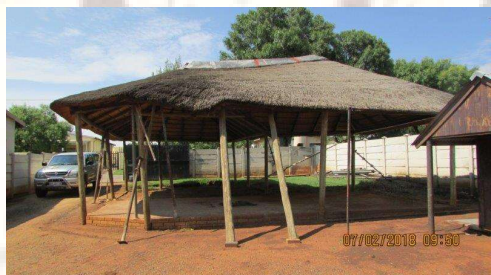
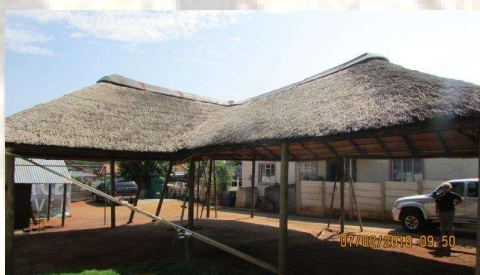
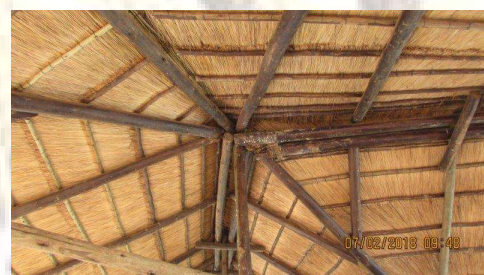
Below are photos of a lapa that has been rejected by our member and whose insurance claim has not been paid out. The size of the lapa is 101 m<sup>2</sup> and the length of the fiberglass ridging 12 m. There is no storm or wind damage visible to the exterior of the lapa. In our opinion the lapa is busy collapsing due to structural failure.

The pole construction as well as the fiberglass ridging that was installed was extremely unprofessionally done.

Currently the structure is a danger and can collapse at any time. Our recommendation is that it be removed as soon as possible.

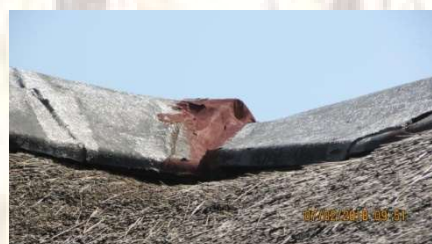
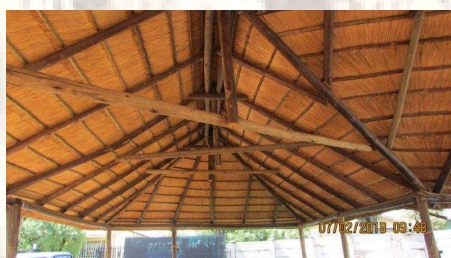
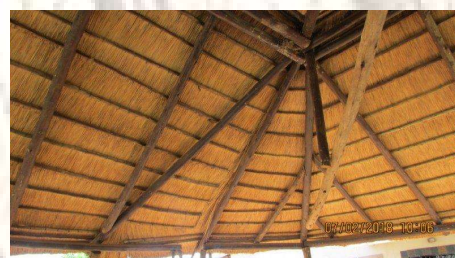
Not only is the diameter of the poles used too thin, they are too far apart. They are only nailed together, splitting open and so the list goes on.

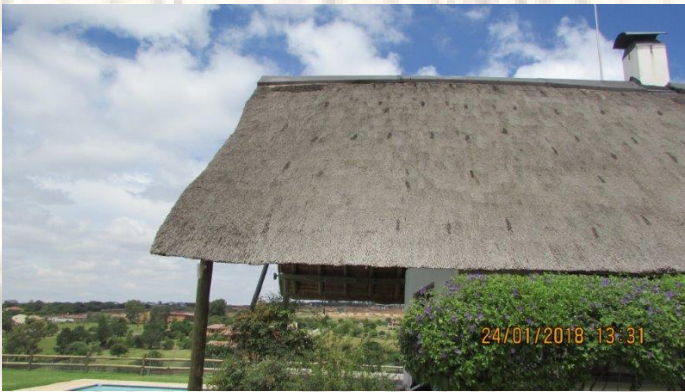
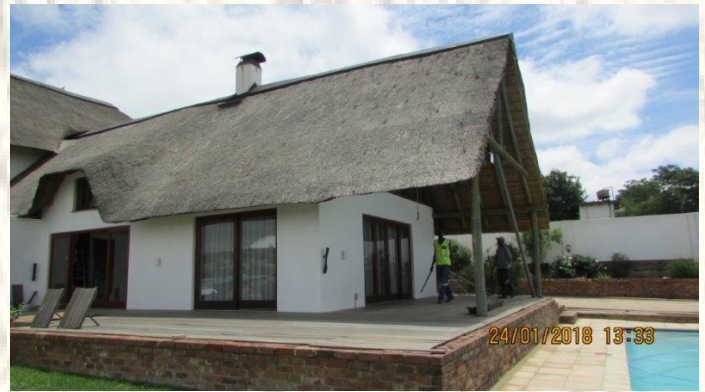
The roof is  $\pm$  11 years old. The width of the building is 7 m with an 800 mm overhang on either side.

The solution to the problem is to remove all the thatch up to the gable wall. Support the existing structure, remove and replace the left column, as well as the two bent rafters in the front, together with new structural members.

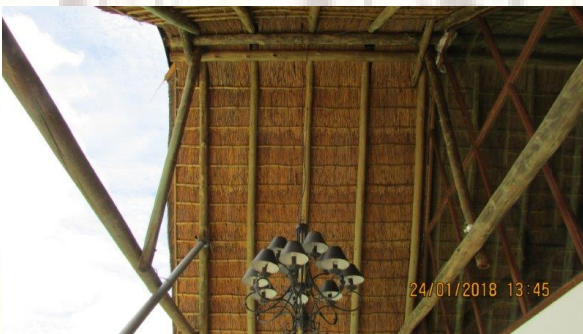
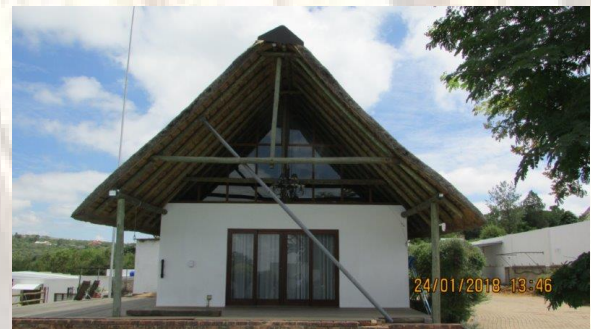
The open verandah extends 3.2 m from the main building and is supported on two wooden columns with a wooden ring beam spanning from the columns back to the wall.

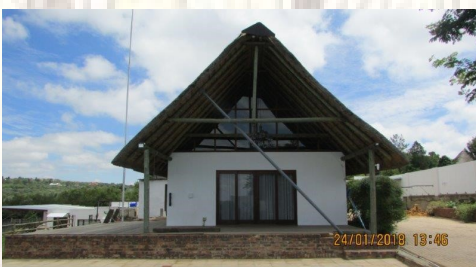
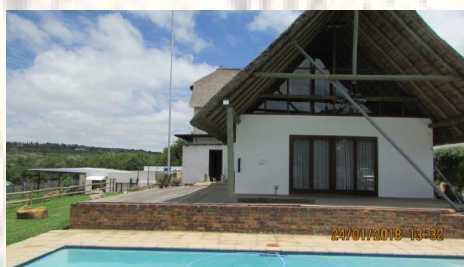
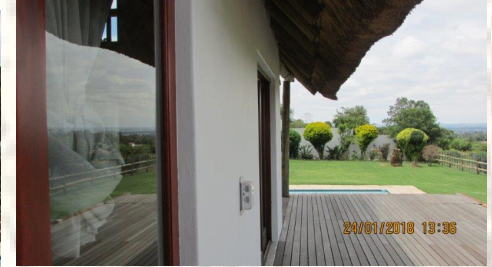
Structurally the roof has two bolted tie-beams, one next to the gable of the building and one in the front. Facing the building it is noticeable that the wooden columns on the left are leaning over outwards, which in return puts additional stress on the two rafters in front. This is held together by the tie-beam and king post. They both have bent considerably.

It is not clear what is the reason for the column leaning over. One possibility is a strong gust of wind that only affected the structure and not the thatch.

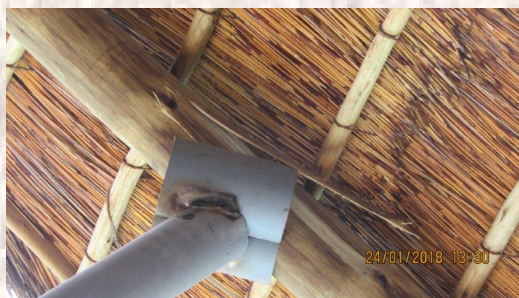
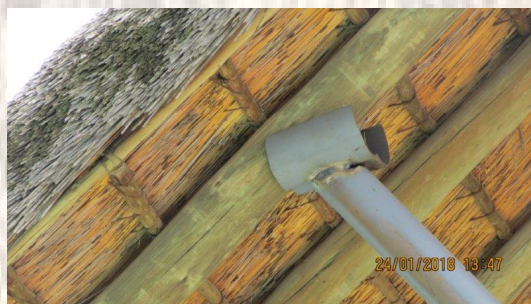
Judging by the photos we are not sure if the left rafter has broken or is it only the bark on the side that split off.
