THATCHERS ASSOCIATION OF SOUTH AFRICA DEKKERSVERENIGING VAN SUID-AFRIKA

Newsletter 5/2015
31 July 2015

Examples of Original Insurance Claims

IS YOUR CONTRACTOR RESPONSIBLE FOR THE FACT THAT YOUR INSURANCE CLAIM IS NOT MET?

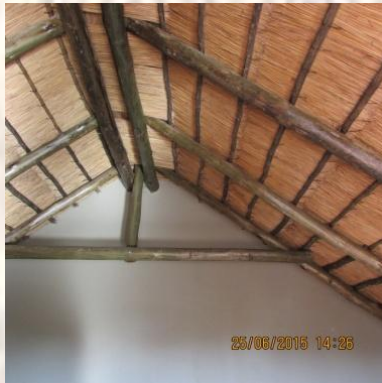
The following is an example of complications due to re-thatch onto original faulty construction:
The size of the roof is 43 m² and the length of the fiberglass ridging 4,5 m.
The roof was designed at an angle of 35° where the optimum for thatch is 45°.

Roof built at 35 degrees

The solution is to remove the existing two layers of thatch as well as the pole construction **and reconstruct the entire roof**. The flashing against the gable also needs to be resealed or replaced if necessary.

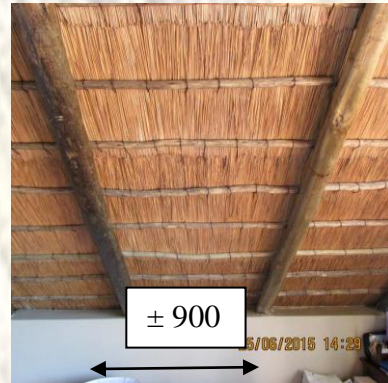
The rafter spacing is between 900 and 950 mm whereas the maximum should not be more than 800 mm.

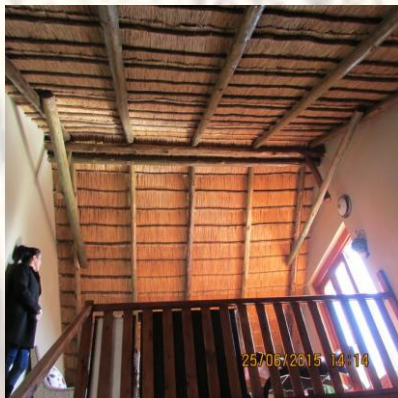
The clear span of ridge beams in the apex of the roof is 4 m where it should not exceed 3 m.

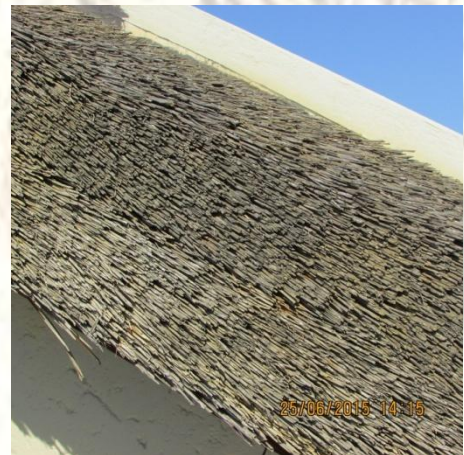
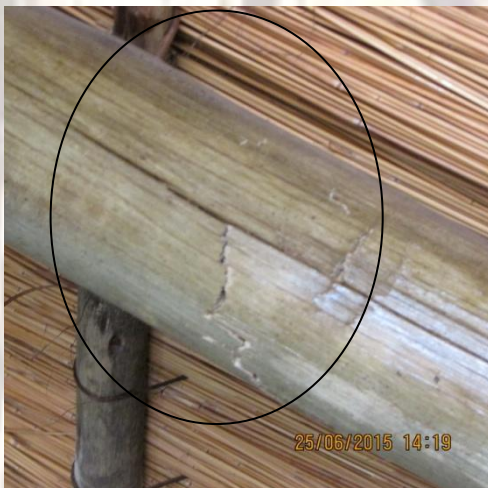
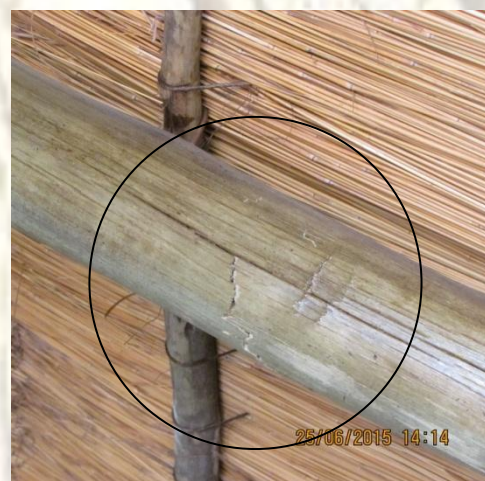
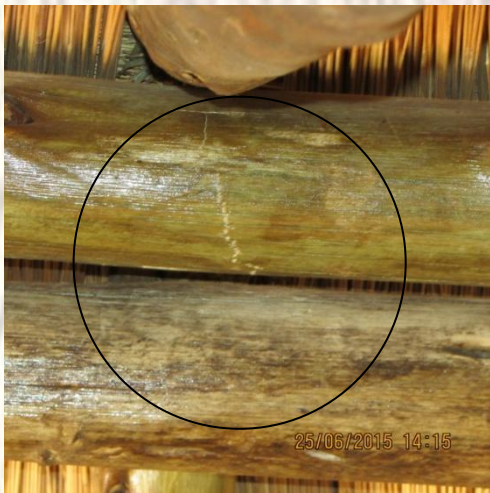
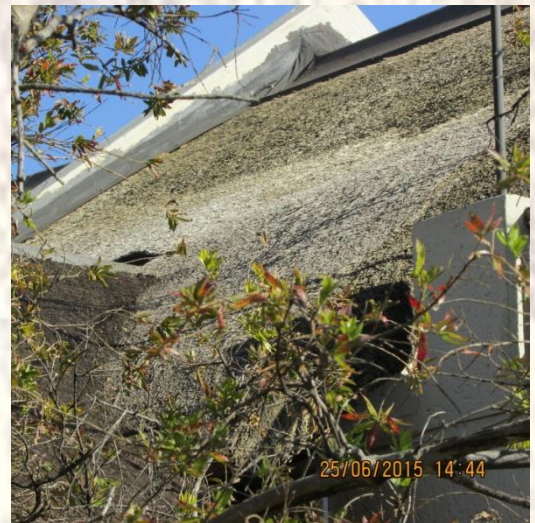
With only one layer of thatch the above might still have been in order but when the second layer of thatch was added on the added stress of the excess weight ($\pm 1,700$ kg) became too much for the existing poles. That is the reason the one rafter as well as the ridge started cracking.

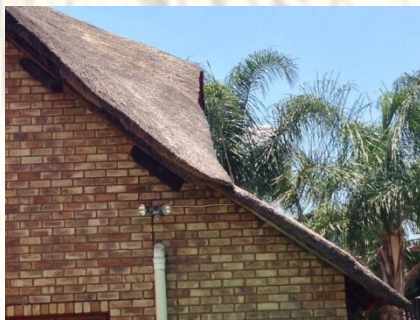
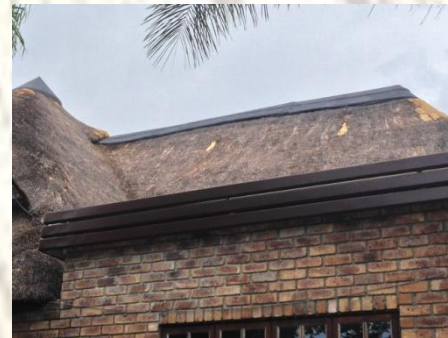
According to the owner there was a severe hail storm and the thatch was damaged. The insurance company appointed a thatching contractor to brush and comb the roof.

Presently the roof is well below the accepted average thickness of 150 mm and the client is complaining about leaks all over.

The result is that some of the thatch is now not secure. In our opinion the main cause of the leaks. The solution is to re-thatch (overlay) the entire house. The second layer must be secure through the existing thatch onto the laths on the inside.

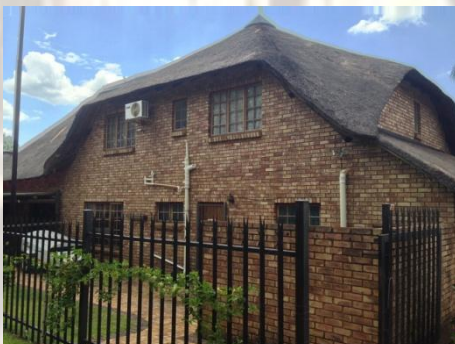
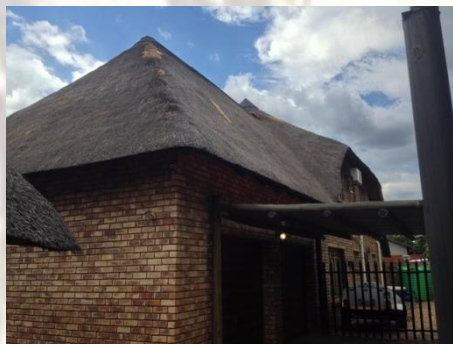
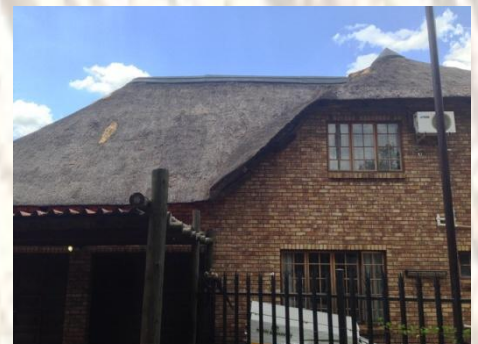
As there is no horizontal wire (sways) visible on the surface of the roof we tested the compaction of the thatch from the inside by pulling the twine. To our surprise, in five different sections of the house the twine was broken and we pulled out pieces.

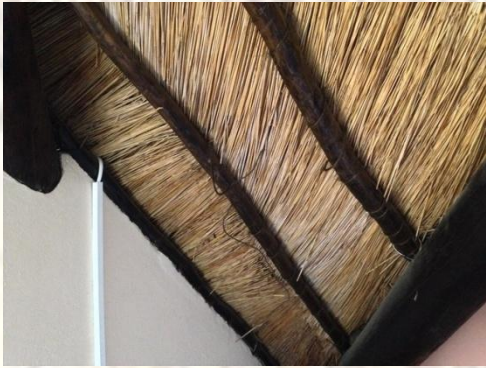
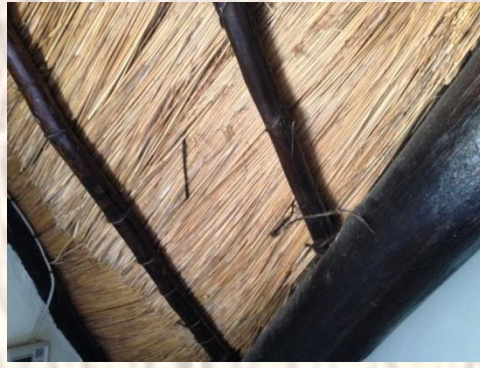
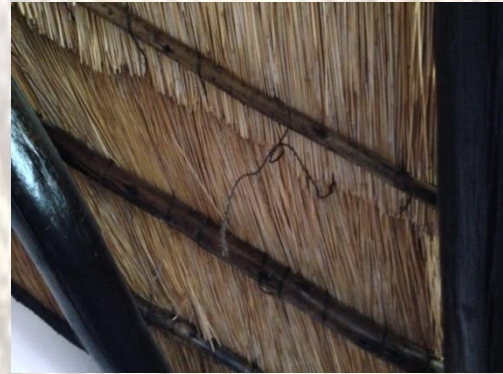
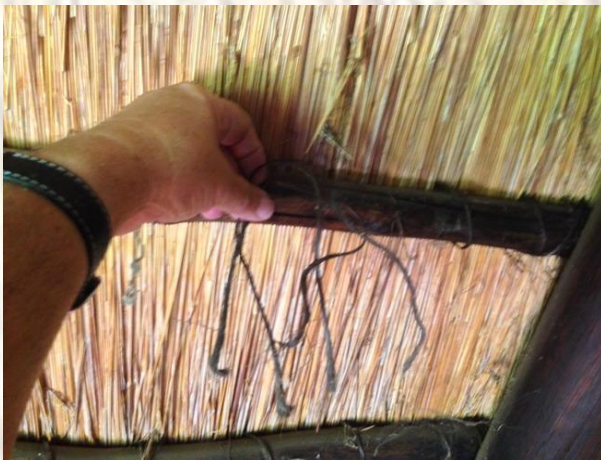
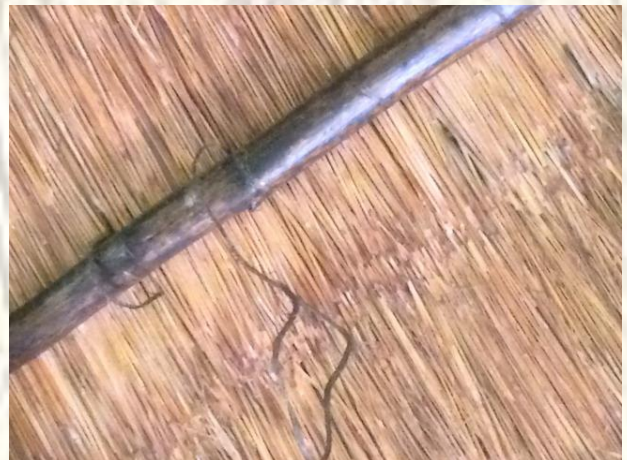
It is difficult to determine whether the twine has been cut or if it was natural deterioration.
