THATCHERS ASSOCIATION OF SOUTH AFRICA DEKKERSVERENIGING VAN SUID-AFRIKA

NEWSLETTER

CHECKS AND ANTI-SPLIT PLATES

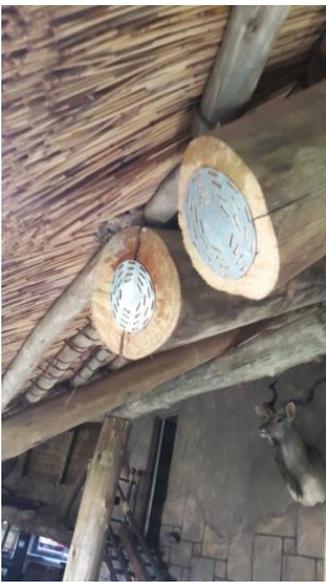
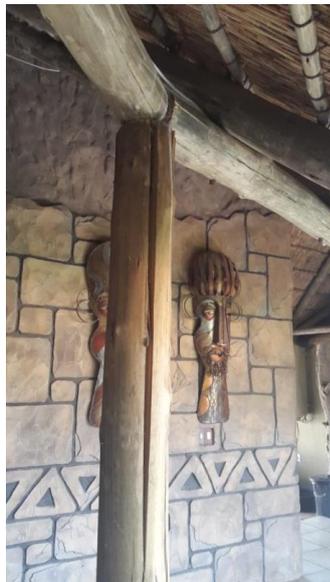
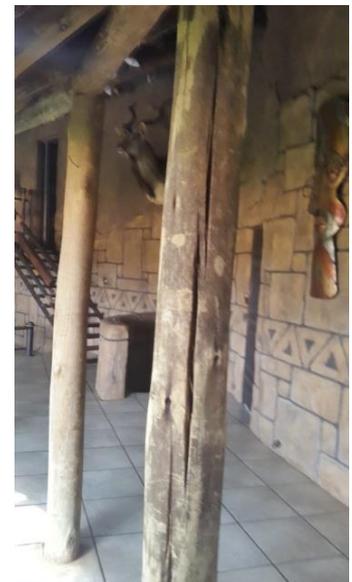
The Thatchers Association's office often receives inquiries regarding, among other things, poles that split and missing nail plates - especially on the interior of thatched roofs.

The problem with thatching poles is that in most cases the poles are cut on site and the anti-split plates are not replaced, or if replaced, the size is not sufficient to prevent checking.

Because it's a natural occurring defect in gum poles SANS 457-3 allows limits to checking:

- Number: 4 per end
- Length
 - o Top end: 200mm or 2 ½ x top diameter, whichever is the greater
 - o Butt end: 300mm or 5 x butt diameter, whichever is the greater
 - The maximum allowance of a single end check (top or butt) may exceed the relevant maximum, but shall not exceed ¼ the length of the pole
- Width: 1/10 the diameter, measured midway along the check
- Depth: may not exceed half of the average mid-length diameter of the pole

- Number: No limit
- Length: ¼ of the length of the pole
- Width 1/8 the diameter of the pole, measured at the midway along the check
- Depth: may not exceed half of the average mid-length diameter of the pole

The nail plates are only a precautionary measure to control end checks which are largely an aesthetic feature.
