THATCHERS ASSOCIATION OF SOUTH AFRICA DEKKERSVERENIGING VAN SUID-AFRIKA

Newsletter 5/2013

ARE THE DAYS OF THATCHED ROOFS COUNTED?

Servicing of thatch roofs

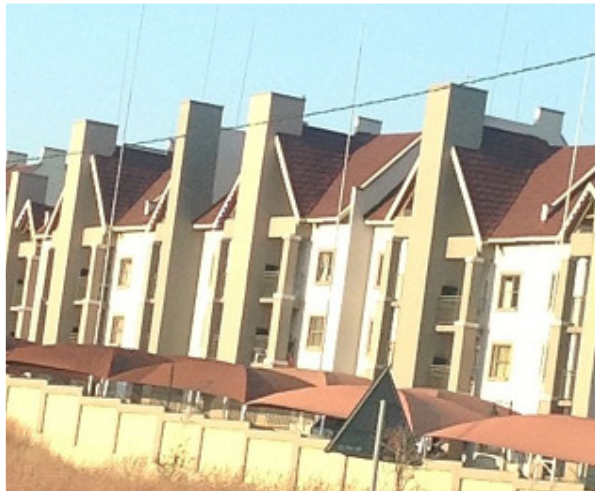
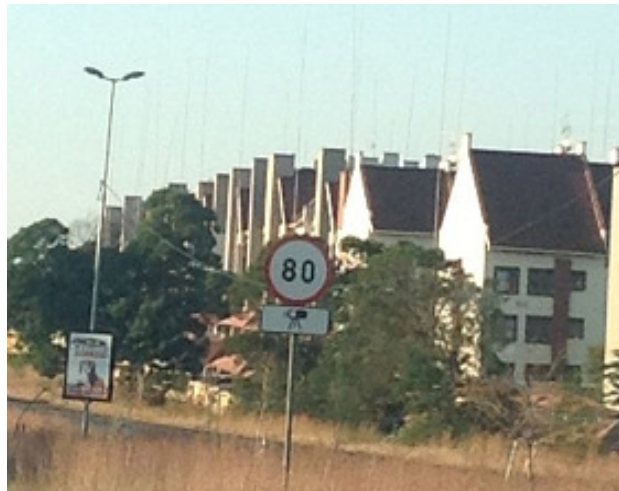
An alarming trend that is becoming more common is the replacement of thatched roofs with tiles. Mr Bertus Nieuwenhuis of Recon Thatchers sent photos (below) and writes as follows: "I spent the weekend driving through Honeydew, past the Coca-Cola Dome. More than half the townhouses' thatched roofs were replaced with tiles. This displayed a very negative image."

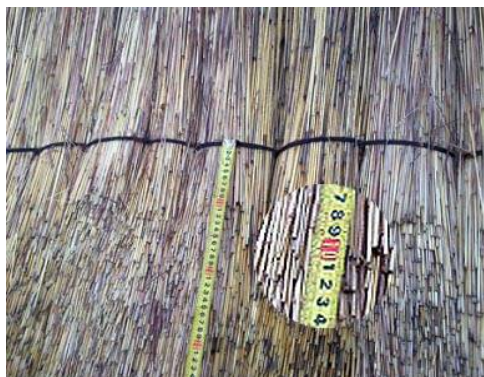
a) Thickness of the thatch for a shortened life span

B.4 Figure B.2(a) shows the incorrect thickness of the thatch, which shortens the lifespan of a thatched roof. Figure B.2(b) shows the correct thickness of the thatch which ensures a longer lifespan for a thatched roof. The lifespan of the roof has a direct bearing on the length of the stem below the twine.

B.5 The lifespan of a thatched roof must be controlled during the thatching process and must be maintained. Care should be taken when 300 mm in common thatching grass is exceeded, due to the fact that the roof could be prone to wind damage.

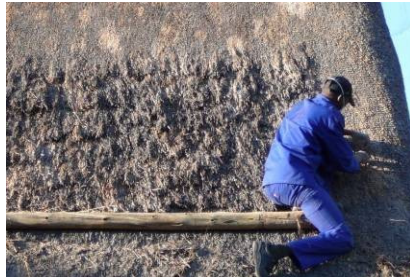
a) Pulling down of the thatch layers of a thatched roof

B.6 Figure B.3(a) shows the method of pulling down the thatch layers. Figure B.3(b) shows the method of tightening the twine after the pulling down of the outer layer of bundles.

B.2 The correct procedure is to inspect the general length of the thatch or reed; if found long enough, the next step is to pull down the thatch layers (see figure 1).
