## THATCHERS ASSOCIATION OF SOUTH AFRICA DEKKERSVERENIGING VAN SUID-AFRIKA

### **GENERAL INFORMATION REGARDING THE COVERING OF A THATCHED ROOF WITH TILES, CORROGATED IRON SHEETS OR ANY OTHER COVERING**

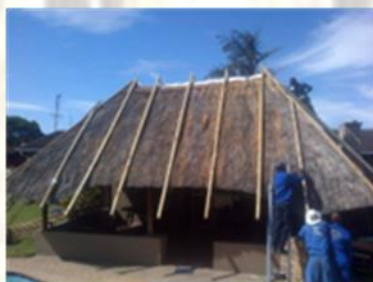
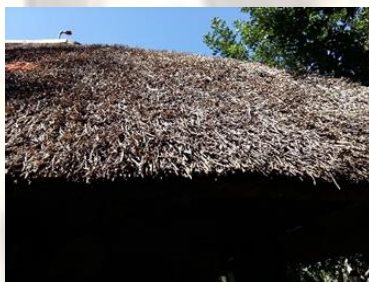
Placing tiles over the thatch creates a void between the two layers. If a fire starts inside the building or roof space, this void supplies oxygen and traps heat, which can significantly fuel the fire.

Complaints are received about birds and especially bats nesting if access can be gained.
