THATCHERS ASSOCIATION OF SOUTH AFRICA DEKKERSVERENIGING VAN SUID-AFRIKA

Newsletter 5/2010
22 September 2010

NEWSLETTER

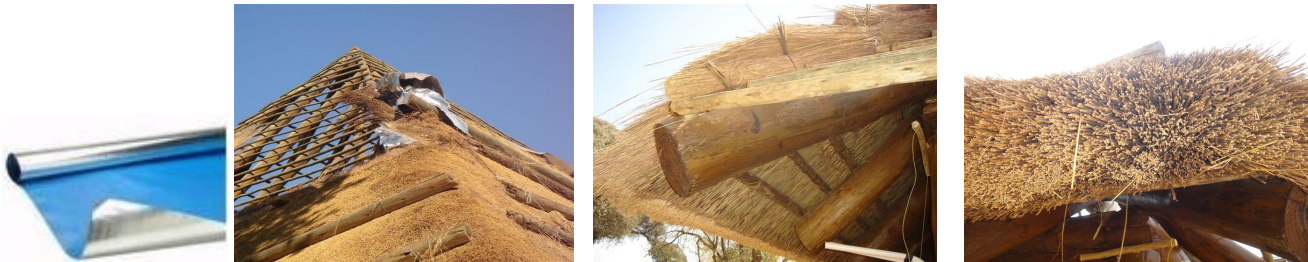
The thatch thickness is tapered down dramatically to the ridge

No compaction

It has come to our attention that some contractors still make use of sisalation. This practice is obsolete and is not recommended as condensation seriously reduces the life span of the thatched roof.

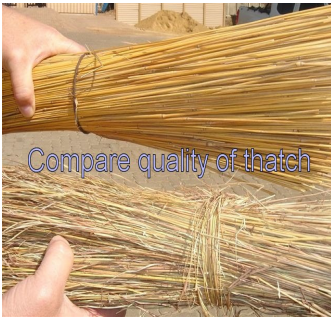
The difference in quality of thatch grass

Contractors are still continuing with the practice of using bad quality and immature grass cut during the growing season. Using this inferior grass together with sisalation is a sure recipe for disaster as these roofs will not last. The protective layer against moist penetration has not been formed yet and is easy to detect because it breaks easily at the joints.

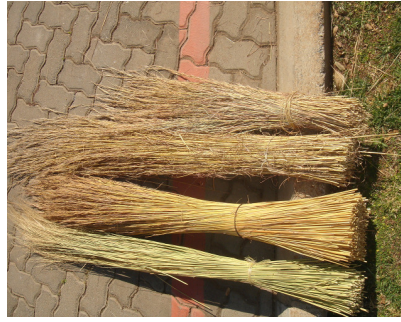
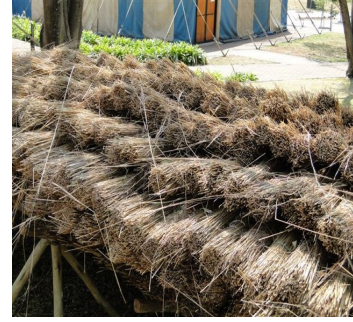
The thatch grass looks woolly

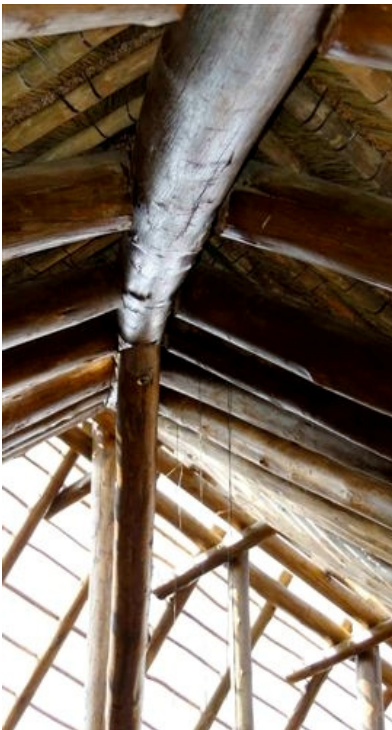
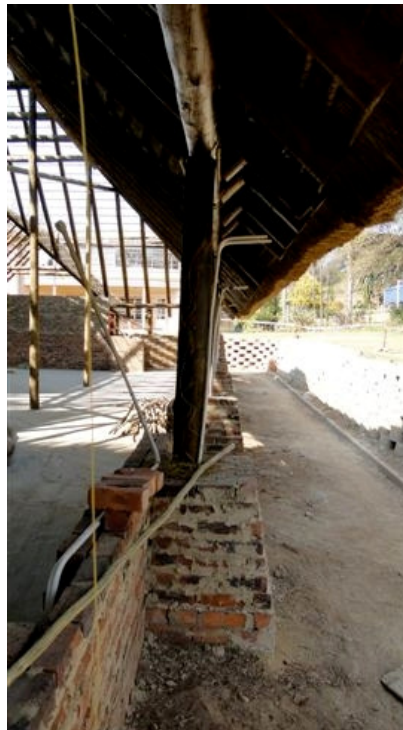
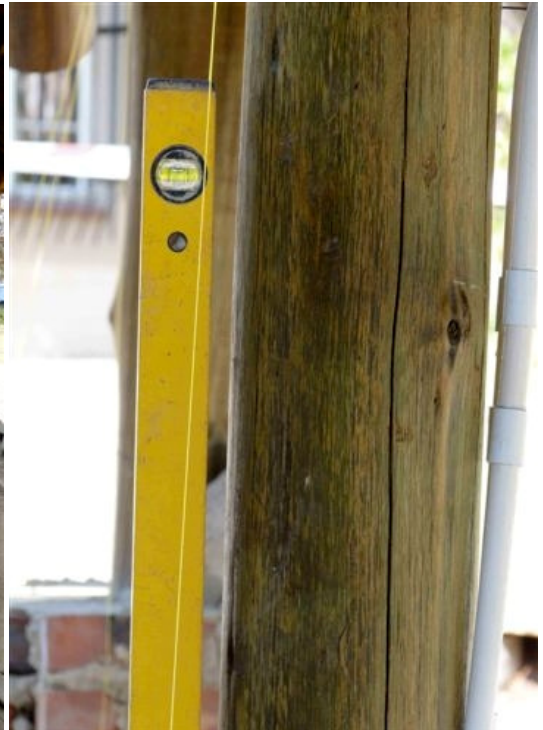
The assistance of Mr Mike Hull (Structural and Civil Engineer) of Hull Consulting Engineers had to be called in to try and save a roof of a client who already paid up R220 000. The roof has been built without approved plans. No support structure was provided on the inside and the roof had to be supported inside as well as from the outside to prevent it from collapsing - this while the kingpost was still standing on the ground.

It is more disturbing to note that the building was built under the supervision of an Engineer. It supports the argument that very few Architects and Engineers are proficient in the design and building principles of pole constructions.
