# THATCHERS ASSOCIATION OF SOUTH AFRICA DEKKERSVERENIGING VAN SUID-AFRIKA

Newsletter 5//2017

25 Julie 2017

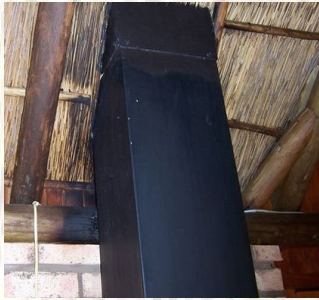
**PROBLEM: The heat of the steel flue through the thatch, causing the thatch to charcolize**

Thatch charcolize as a result of the heat from the steel

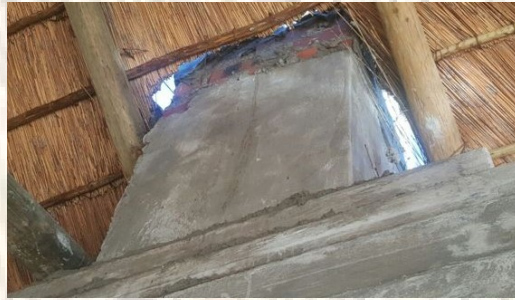
An opening cut through the thatch and a single brick wall built around the steel

**An example of how the problem can be solved.**

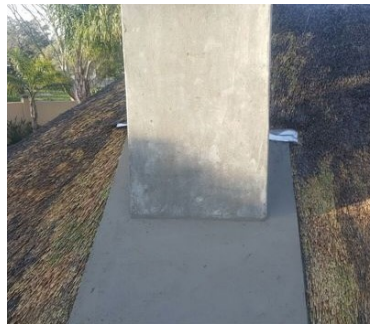
Finishing outside

Single stone wall surrounding steel flue and expanded above thatch roof  
By using the brick wall the leaking against the steel could be corrected

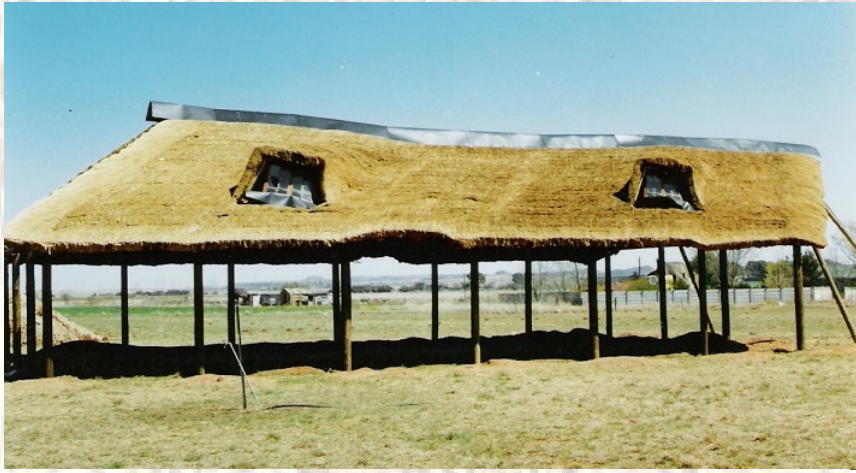
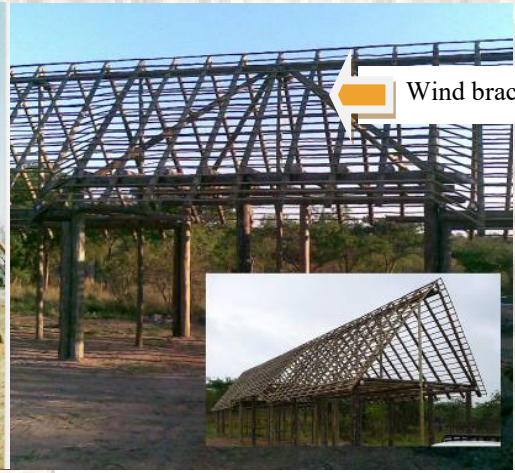
Failures like this roof with wind damage are no advertisement for our industry. The lack of windbreakers (wind bracers) are among other things, the reason for the failure of this roof.

The weight of a thatch roof with poles is about 80 kg per sq.m and with wind load approximately 121 kg per sq.m..

Show wind brace support beams bolted to the underside of rafter poles
